Workshop

**Energy infrastructure
resilience in response
to war and other hazards**

Rehabilitation of partially damaged during the war school and kindergarten buildings with accordance of energy efficiency requirements

POLAND, Rzeszów, 24.09.2024

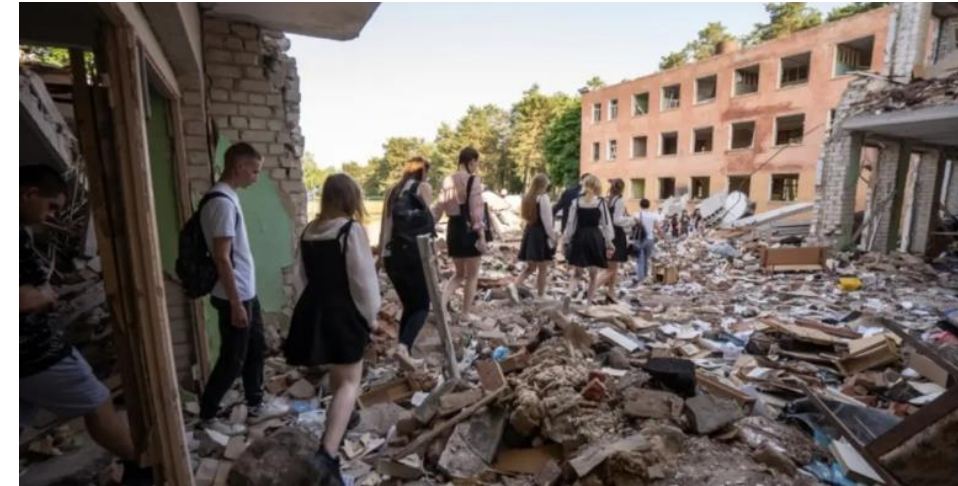
*Destroyed school in Chernihiv / Photo: Oleksandr Gulich
https://24tv.ua/education/skilki-zakladiv-osviti-ponishhili-rosiyani-ukrayini_n2626819*

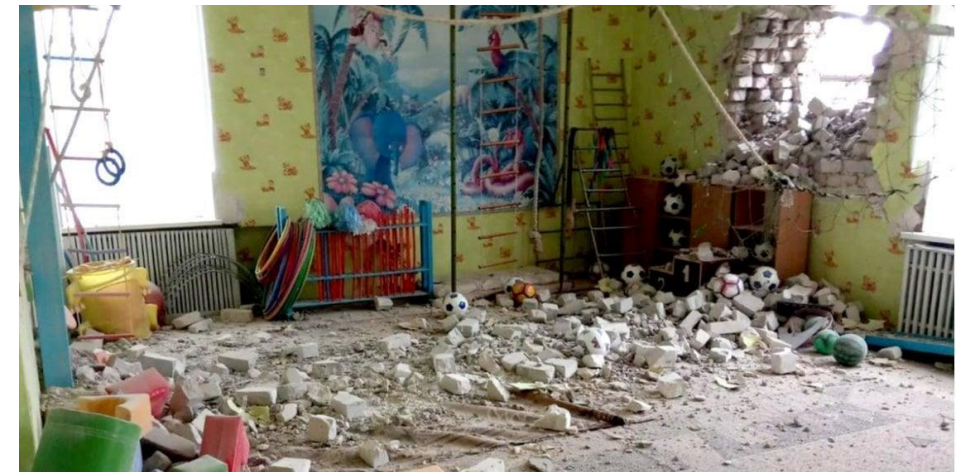
*Destroyed kindergarten
<https://static.nv.ua/>*

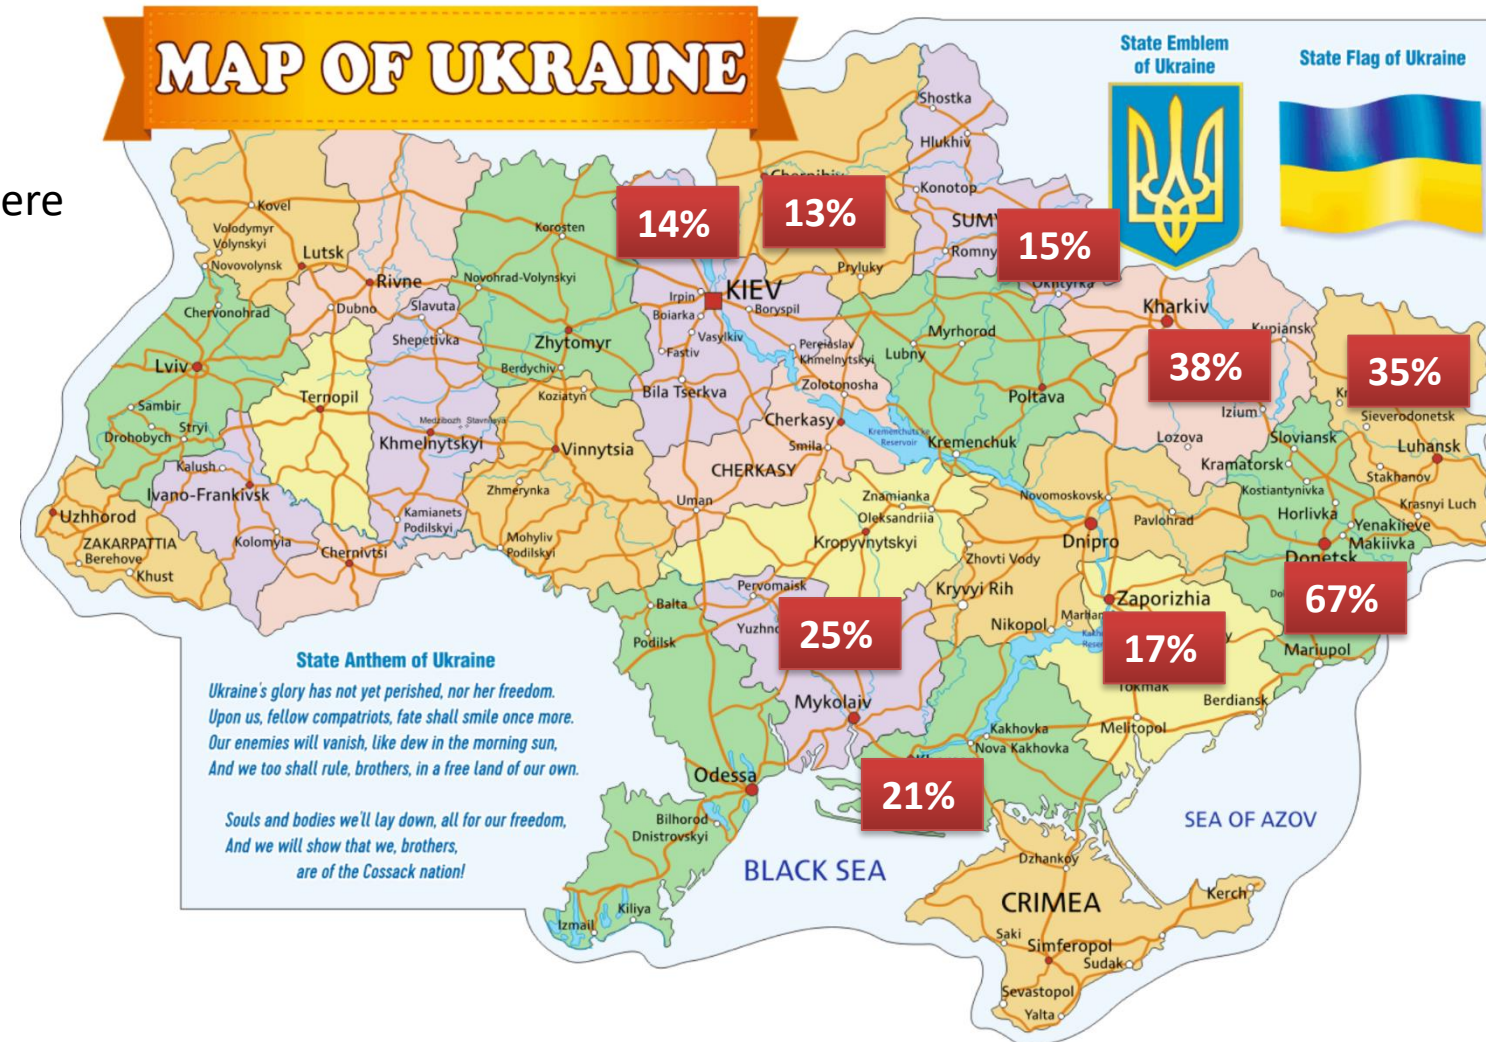
Geography of damaged or destroyed schools and kindergartens in Ukraine

According to Forbes, educational institutions were most destroyed or damaged in frontline areas:

- Donetsk - 67.27%;
- Kharkiv - 37.79%;
- Luhansk - 35.14%;
- Mykolaiv – 25.53%;
- Kherson - 20.95%;
- Zaporizhzhia - 16.8%;
- Kyiv – 13,5%;
- Chernihiv – 12,7%.

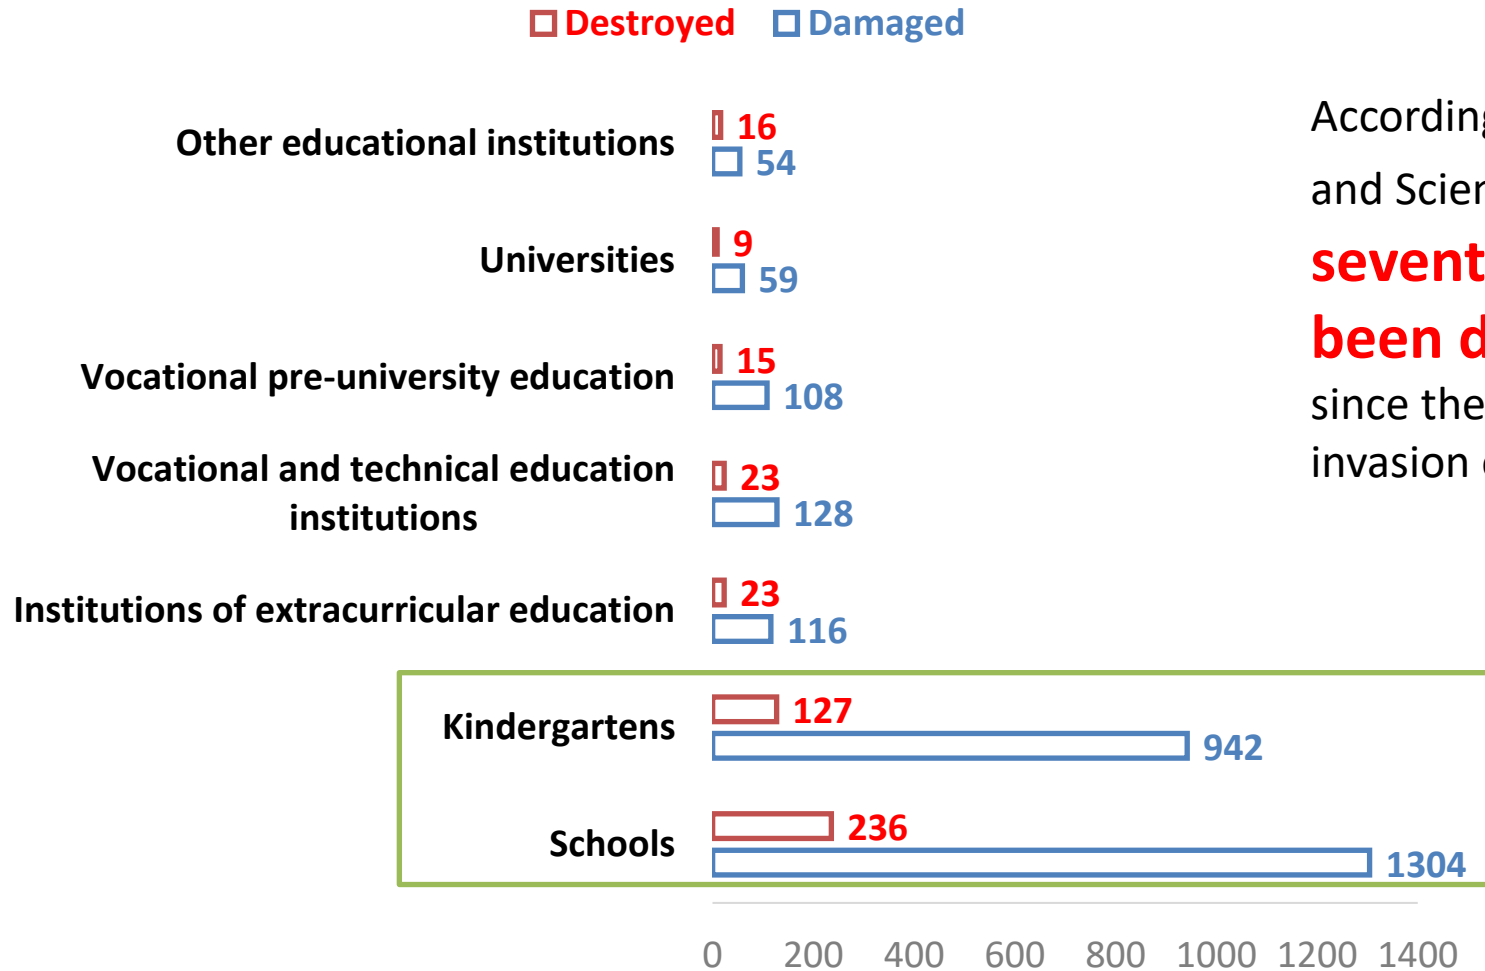
The number of schools and kindergartens destroyed or damaged due to the war in Ukraine

According to the Ministry of Education and Science of Ukraine, **every seventh school** in Ukraine **has been damaged** or **destroyed** since the beginning of the full-scale invasion of Russia.

During the 900 days of war in Ukraine, **2,600 schools and kindergartens were destroyed or damaged.**

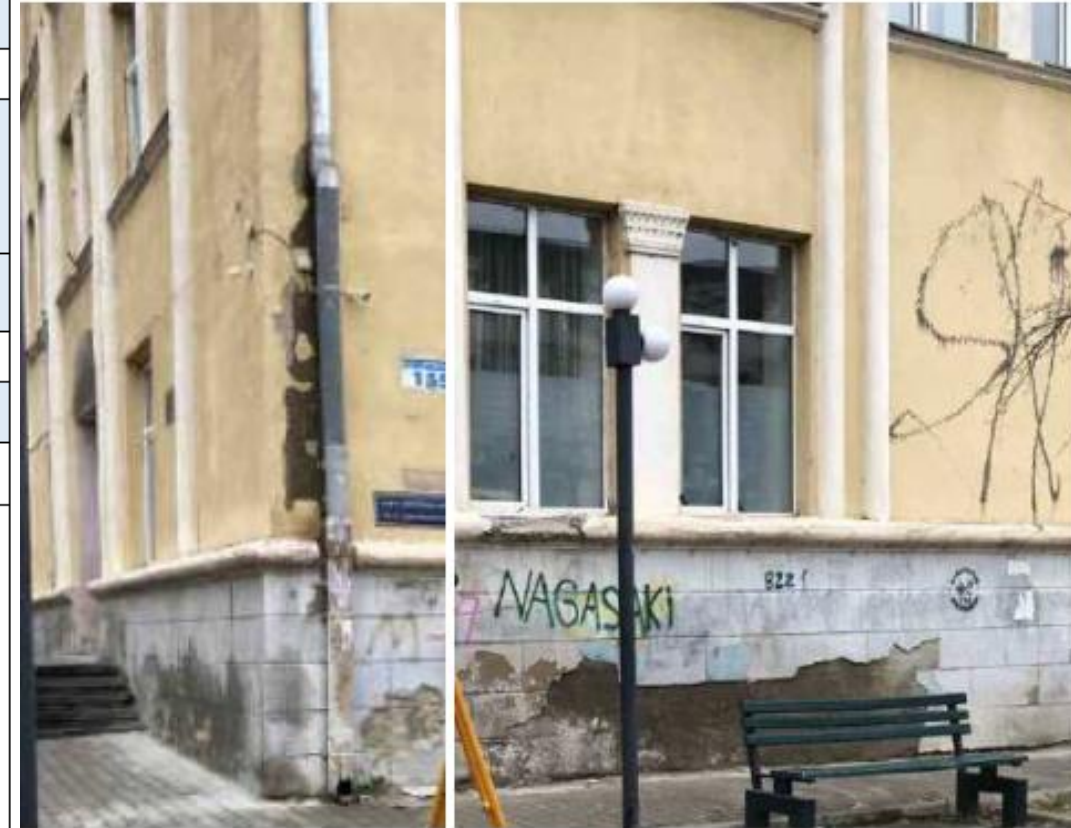
Exterior walls					
General assessment of the condition of the walls			Unsatisfactory		
Total area of exterior walls (excluding windows/doors area)	3 748		m^2	Heat transfer Coefficient $U_{average}$	1.63 $W/m^2 K$
Type of wall	Material Type	Insulation Type	Insulation Thickness	Slab Thickness, m	Area, m^2
Solid wall	Silicate Brick	-	-	0.4	4 641
Orientation	North-East	South-East	South-West	North-West	
Wall NET area	1 128	936	914	770	
Description	<p>The wall is built of silicate brick with a coefficient of thermal conductivity $\lambda=0.95 W/m^*K$. Thickness is $\delta=0.4 m$, Inner plaster is Gypsum $\delta=0.01 m$, $\lambda=0.5 w/m^*K$. External plaster is Sand-Cement plaster $\delta=0.02 m$, $\lambda=1.6 w/m^*K$.</p> <p>The existing thermal resistance of the wall is calculated as follows: $R_0=1/8.7+0.4/0.95+0.01/0.5+0.02/1.6+1/23 = 0.61 m^2* K/W$ The heat transfer coefficient is: $U= 1/0.61= 1.63 W/m^2* K$</p>

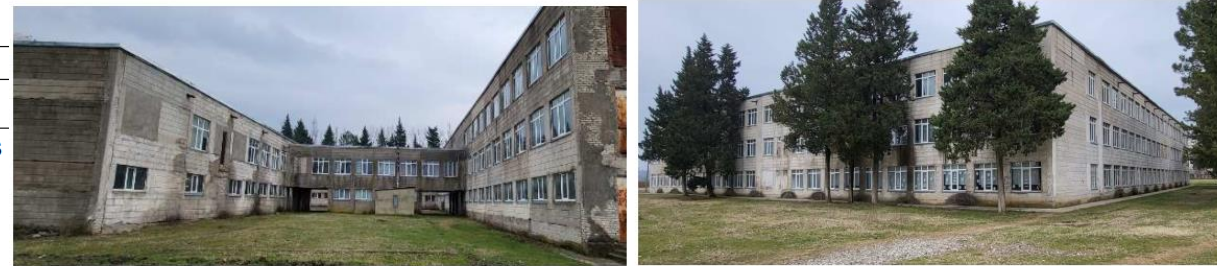
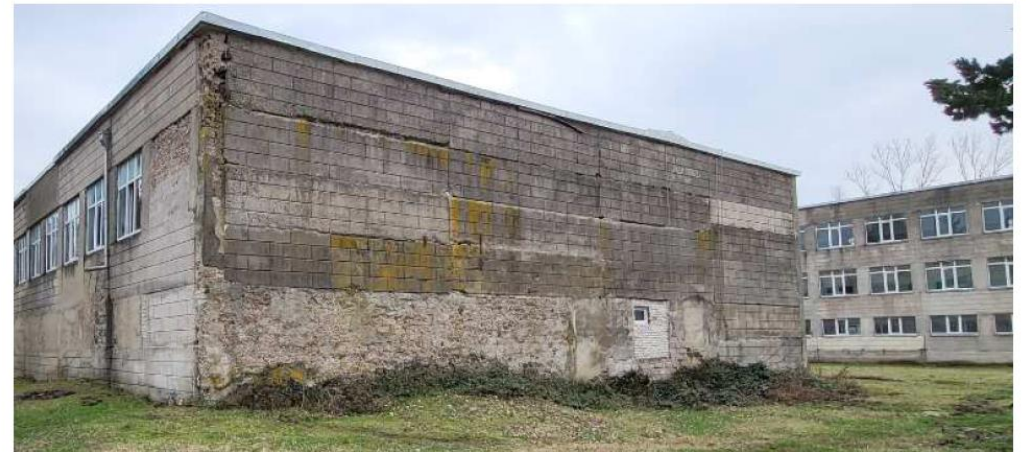
Picture:2- School External Walls

External Walls								
General evaluation of the condition of the walls				Poor				
Total area external walls		2363		m ²	U _{value} (average)	1,88		W/m ² K
Orientation	N	NE	E	SE	S	SW	W	NW
Wall area	623.87		593.32		538.69		607.12	
Material type	precast block	-	precast block	-	precast block	-	precast block	
U _{value} , W/m ² K	1,88	-	1,88	-	1,88	-	1,88	
Insulation type	No		No		No		No	
Material type	<ul style="list-style-type: none"> Precast block thermal conductivity coefficient $\lambda = 1.51$ W/mK. Wall thickness $\delta = 0.45$ m. Internal gypsum plaster thickness $\delta = 0.025$ m, internal plaster thermal conductivity coefficient $\lambda = 0.56$ W/mK, external plaster sand-cement mortar thickness $\delta = 0.025$ m, and thermal conductivity coefficient $\lambda = 0.76$ W/mK. $R_{req} = 1/8.7 + 0.025/0.76 + 0.45/1.51 + 0.025/0.56 + 1/23.3 = 0.53 \text{ W/m}^2\text{K}$ $U_{value} = 1.88 \text{ W/m}^2\text{K}$

Insulation	No

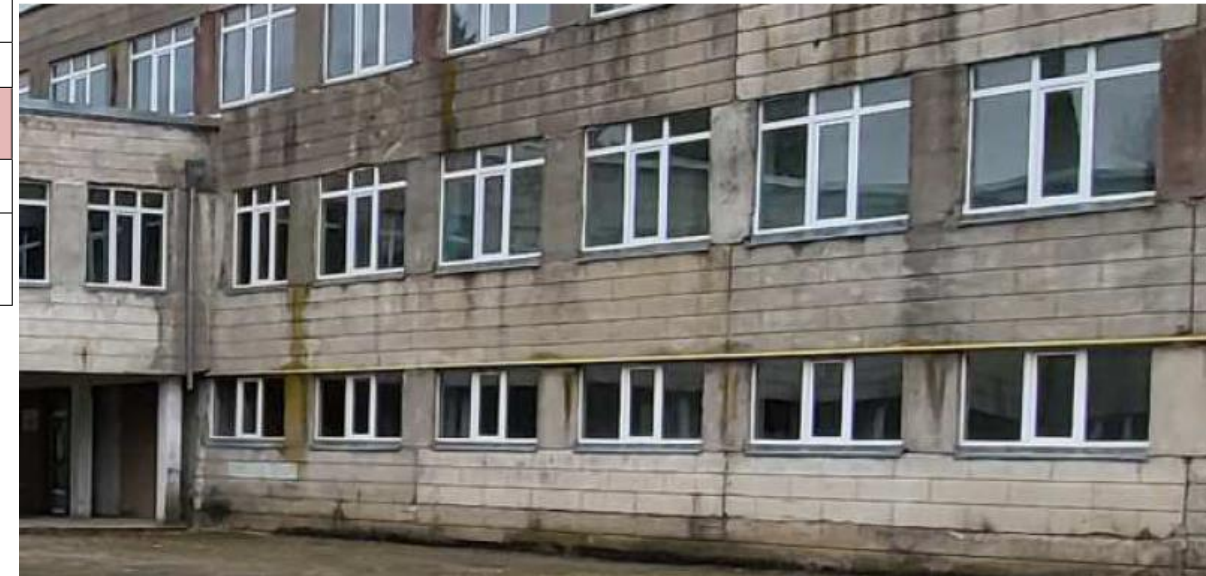
Picture:3- School Windows

Windows						
General evaluation of the condition of windows					Damaged	
Total area windows			966		m ²	U _{value} (average) 2,9 W/m ² K
Orientation	Material ¹	Type ²	Area	Quantity	Solar energy absorption coefficient	U _{value}
			m ²	unit	g	W/m ² K
Building						
N	P	2G	206,15	69	0,5	2,9
E	P	2G	274,75	94	0,5	2,9
S	P	2G	291,35	100	0,5	2,9
W	P	2G	193,75	64	0,5	2,9
Total both wings			966	327		
Material¹	Wood (W), Aluminium (Al), Plastic (P) , Steel (St)					
Type²	Single-frame (S), Double-frame (D), Bonded frame (B), Single glazed (1G), Double glazed (2G) , Triple glazed (3G)

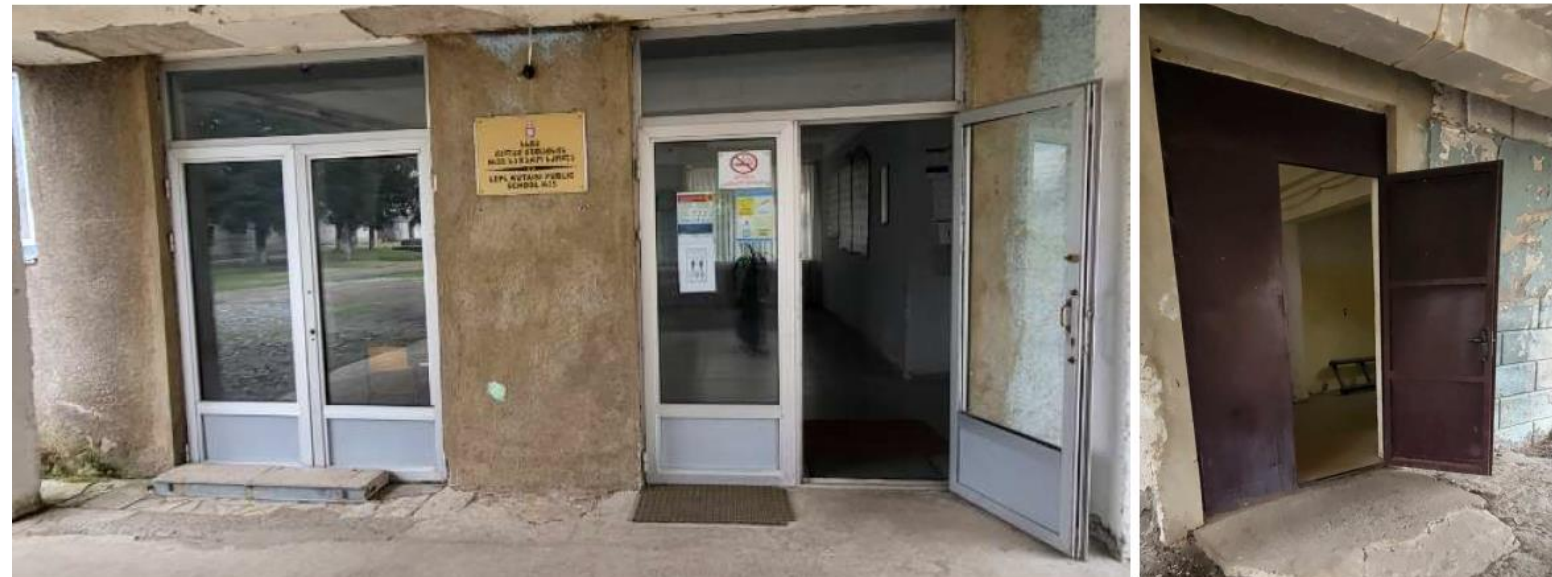
Picture:4- School Doors

Doors					
General evaluation of the condition of doors:					Poor
Steel doors		37,41	m ²	U _{value} St	6 W/m ² K
Material ¹	Wood (W), Aluminium (Al), Plastic (P), Steel (St)				
Type ²	Single-frame (S), Double-frame (D), Bonded frame (B), Single glazed (1G), Double glazed (2G), Triple glazed (3G)

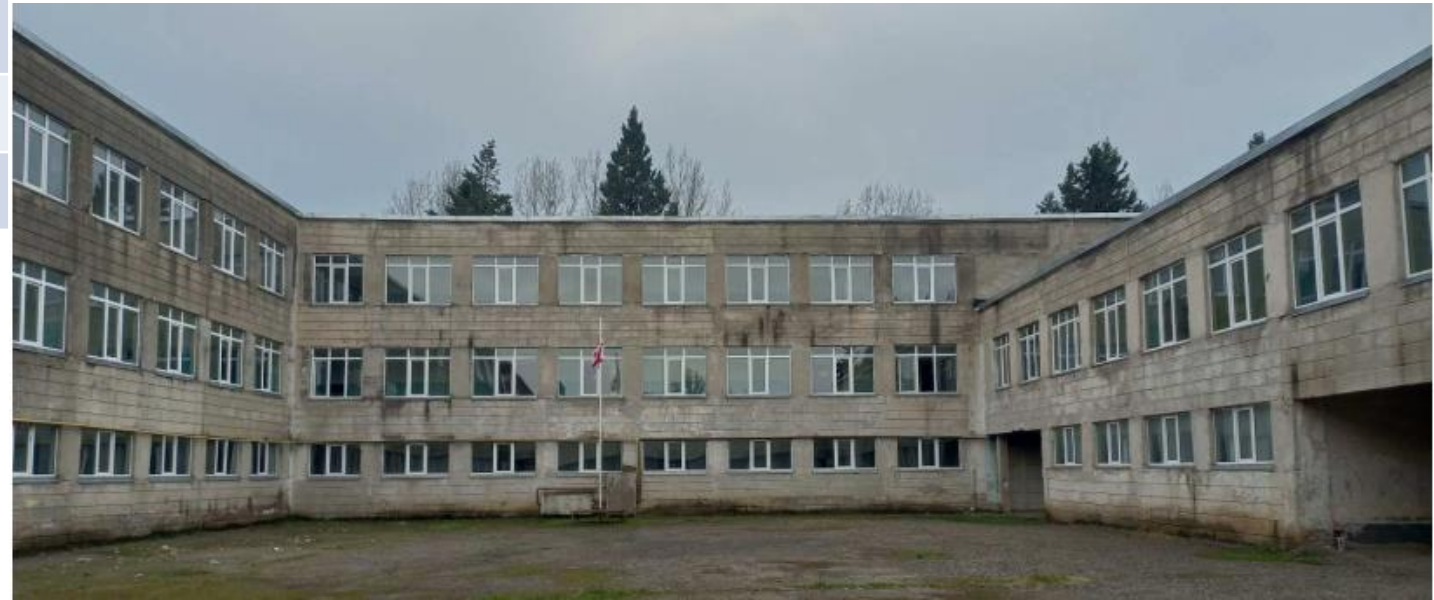
Distribution of heat losses of the building

Part of the building	Percentage
Windows and doors	27%
Walls	23%
Roof	17%
Ventilation and Infiltration	16%
Thermal bridges	9%
Floor	8%
TOTAL	100%

Heat balance of the school building, simulated during heating season with normalised climate data was obtained.

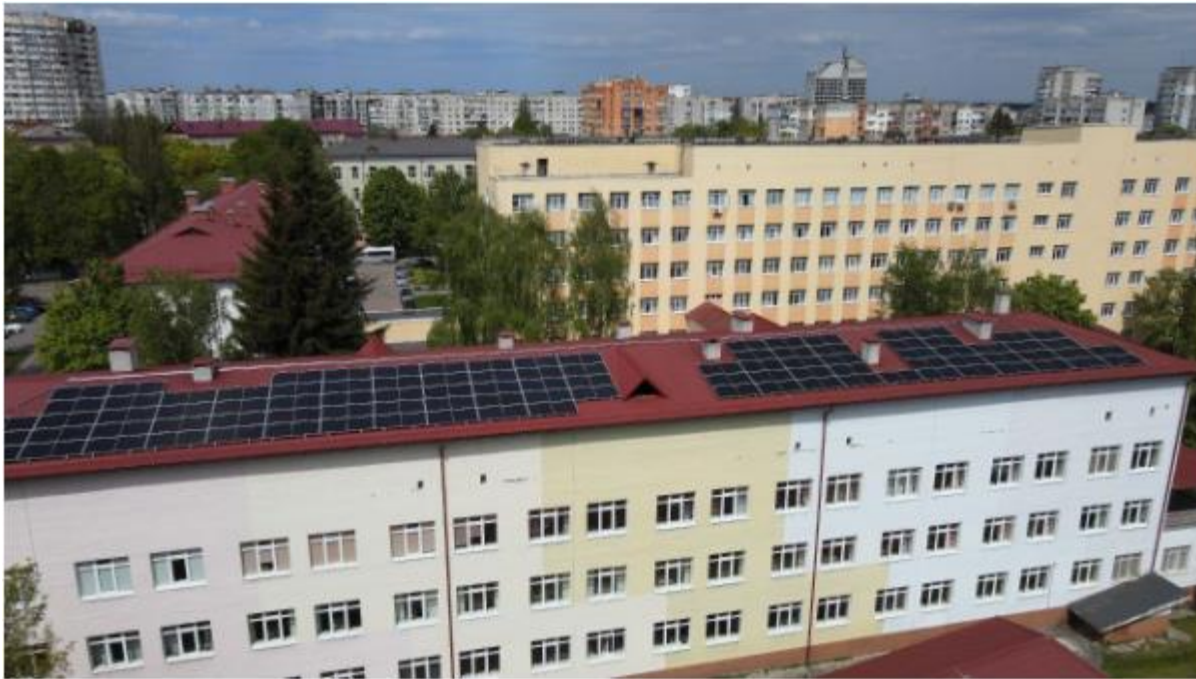
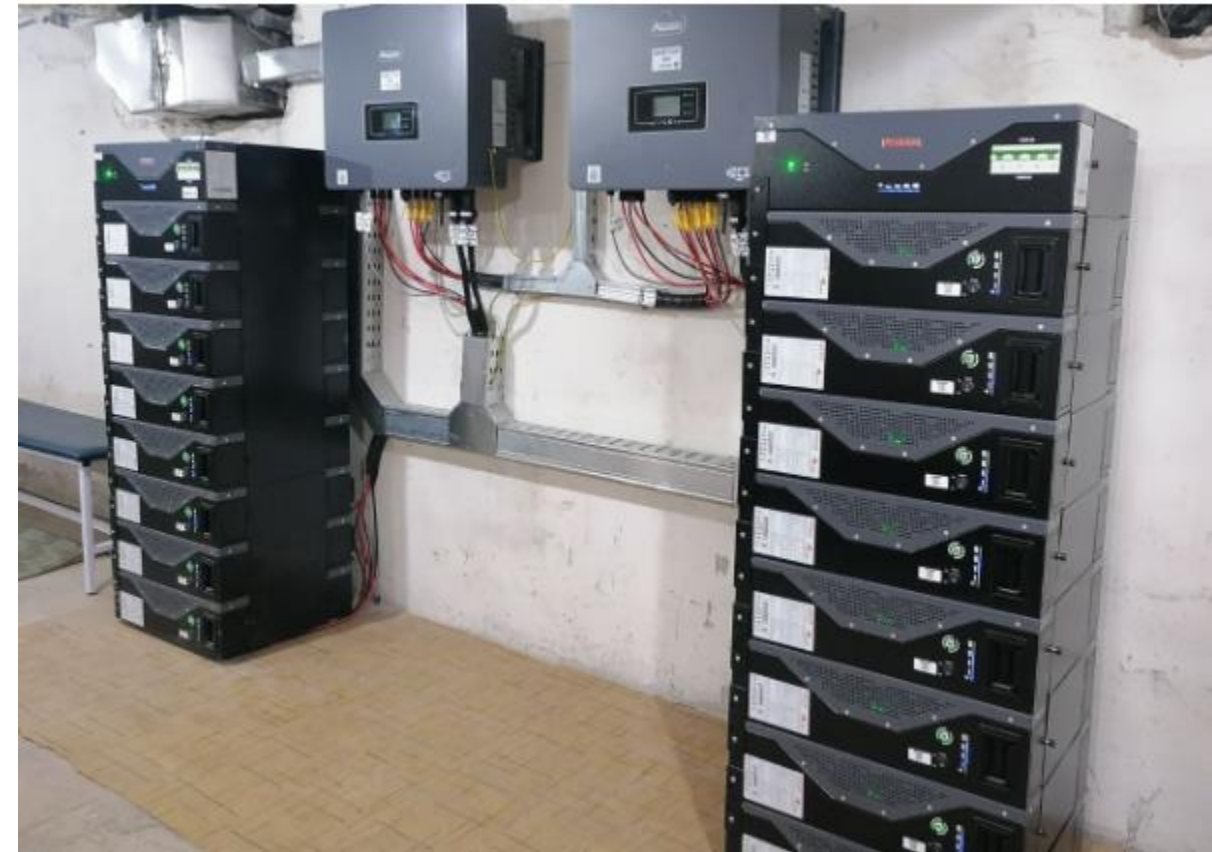
Energy Efficiency Potential: Example of installation of Hybrid Solar power plant in Chernihiv

The power of the solar station is 35 kW, and the capacity of the installed energy storage system is 96 kWh.
